**LEVEL 2**

# Your survey report

0068792

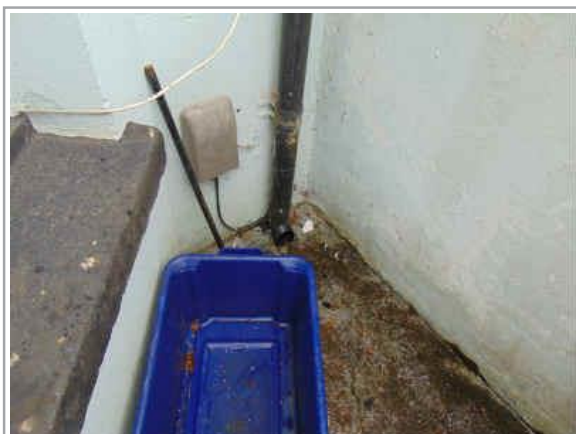
Rainwater pipe onto ground - front

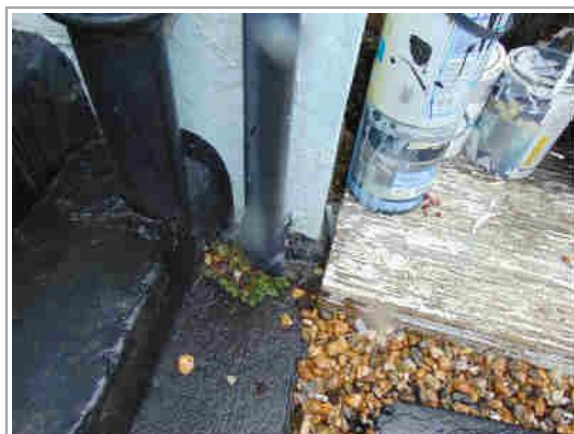
The downpipe at the rear of the property discharges onto the ground close to the bathroom. This could contribute to dampness and the downpipe should be re-directed.

Downpipe onto ground - rear

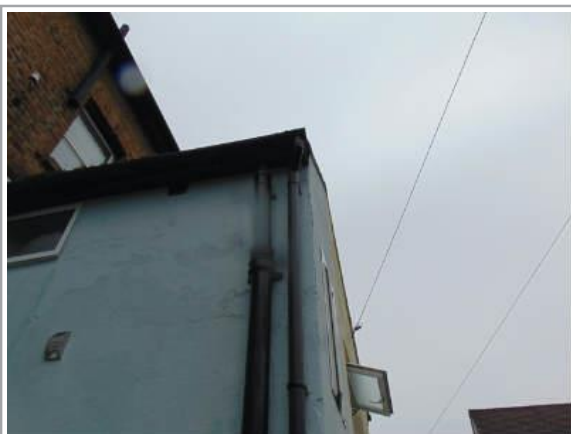
The rendering is in part defective to the upper maisonette. It is also defective in relation to the subject property by the wc section of the bathroom at ground level and repairs are required to reduce the risk of damp penetration. Rendering to the front bay has been patch repaired and some render is missing; additional repairs are required.

Defective render - rear

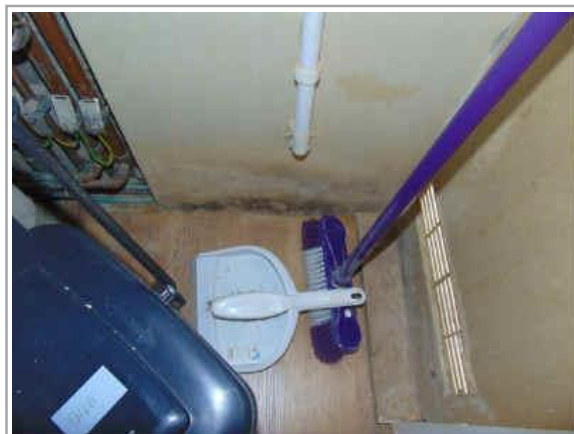
Excessive moisture meter readings were obtained in particular to the front wall of the bedroom, to the wall dividing the bedroom from the kitchen/living room, the external rear wall beneath the boiler and to internal wall surfaces within the bathroom where there are plasterboard linings. This indicates the presence of rising dampness.

Dampness

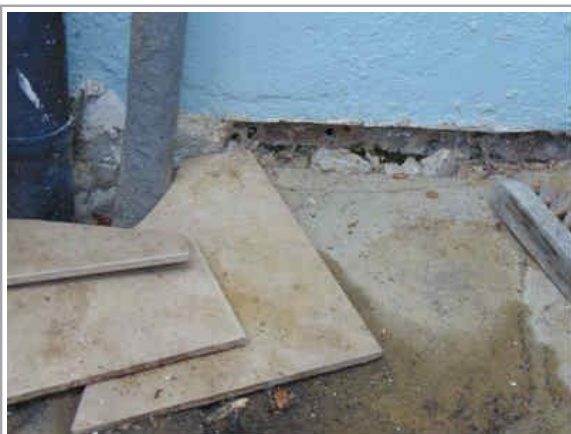
Injection holes - damp proof course

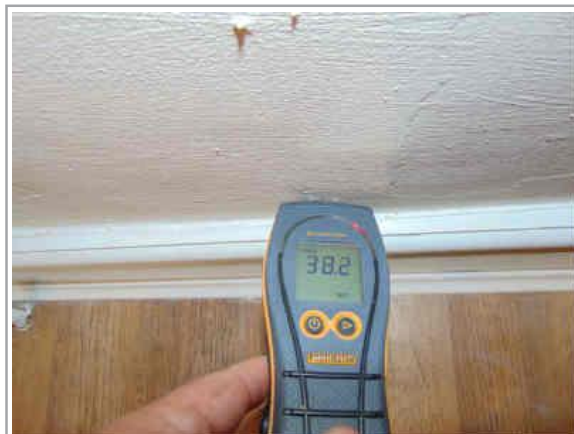
Dampness

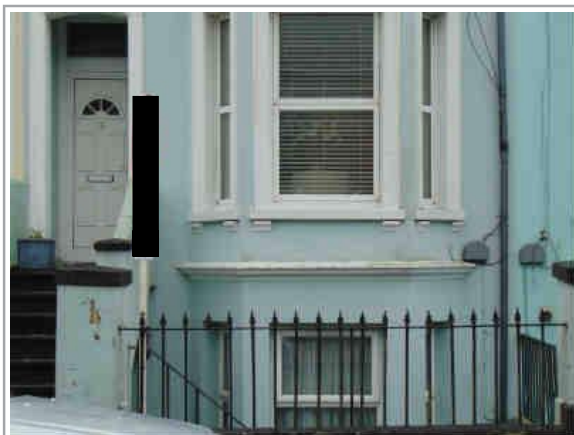
Distortion - bay

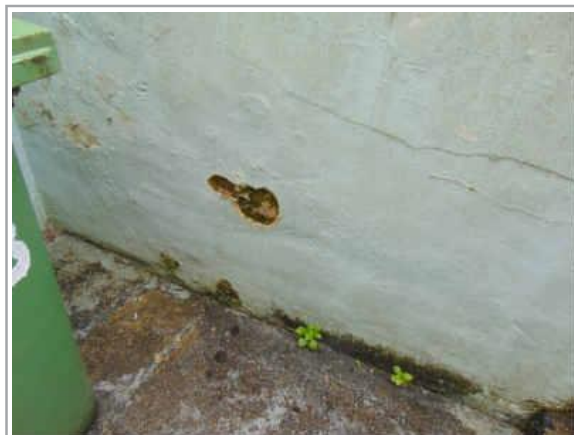
Defective render

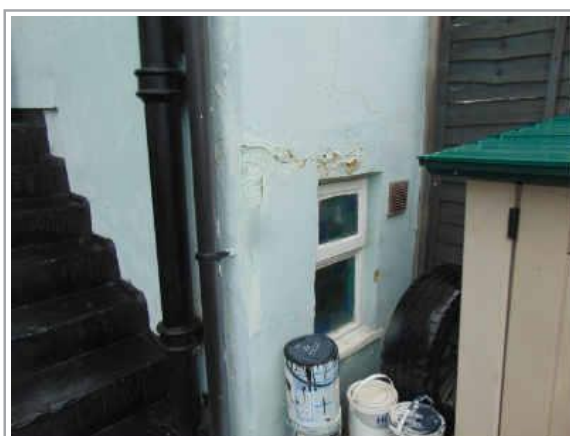
There is a timber window to the wc which is decayed and in need of replacement.

Defective render - decayed window

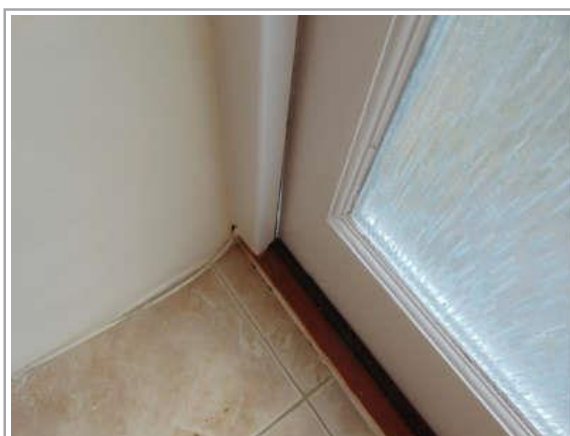
There are timber double glazed doors to the rear of the property which are ill-fitting. We can see the sealed unit to the glazing has failed. Additionally, the glazing is not in safety glass which is a hazard. Replacement of these doors is advised.

Ill-fitting back door

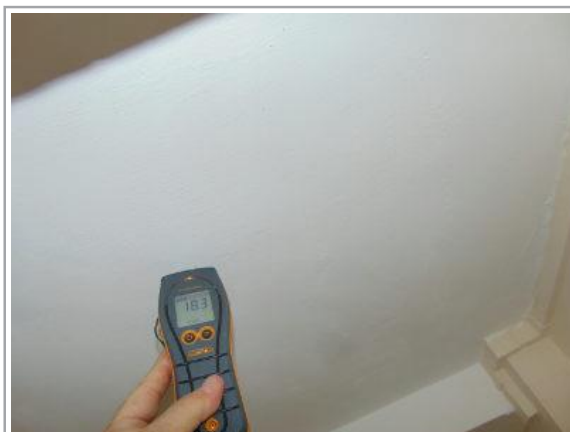
Excessive moisture meter readings were obtained to the ceiling over the wc which might be associated with dampness penetrating through the steps to the upper maisonette as outlined earlier. The specialist damp report should extend to an examination of this ceiling.

High moisture readings

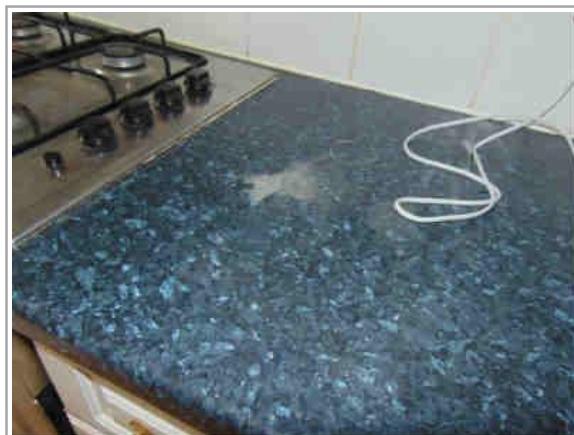
Kitchen fittings are old, worn and exhibit signs of damage. We anticipate a typical purchaser for a property of this age and type will ultimately seek to replace the fittings.

Wear - work surface

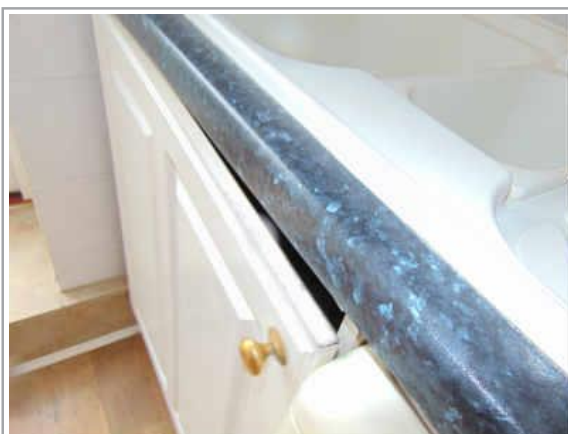
Wear - cupboard front

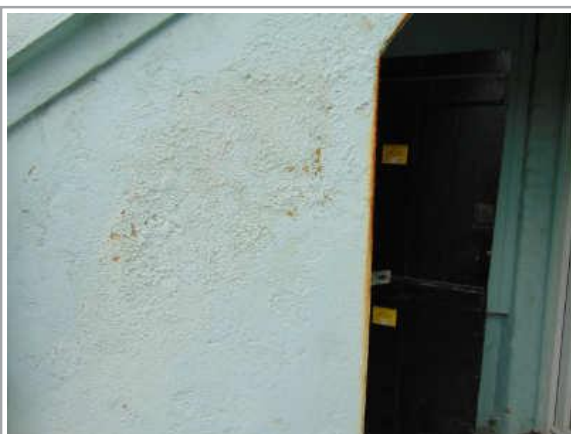
There is an understairs cupboard to the forecourt. This is inevitably inherently damp. Walls are rendered and the rendering is in part defective and metal lathing on the corner of the wall is corroding. Repairs are required.

Defective render

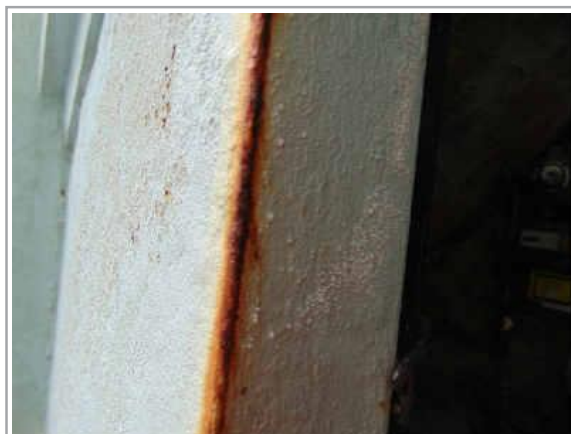
Rusting lathing

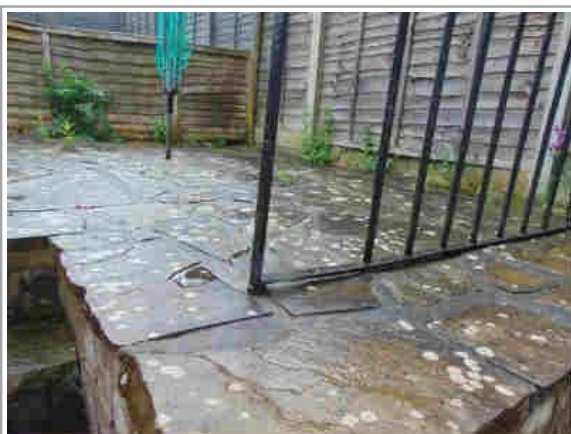
Boundaries to the front are marked by rendered walls with metal railings. Metal railings to the upper garden are in part stable and there is a missing baluster requiring replacement. Timber fencing and the timber gate to the back garden are defective and in need of replacement.

Metail railings - upper garden

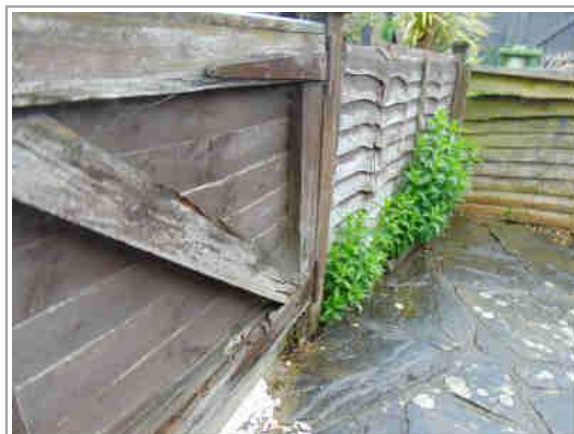
Defective fencing/gate
