LEVEL 2

Your survey report

Property address

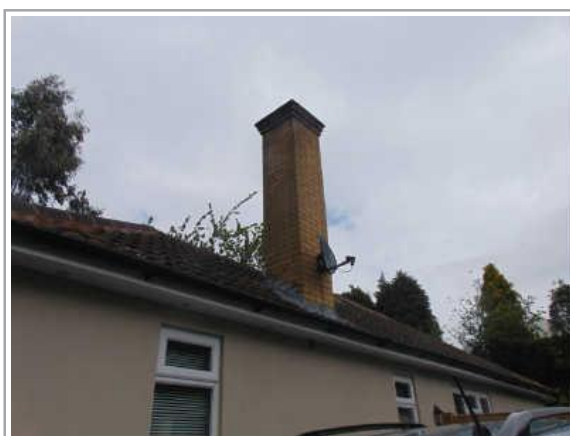
Chimney

There is a brick built chimney stack incorporating lead flashings and a damp proof membrane. There was originally a second chimney which has been removed. 1

Condition rating: 1

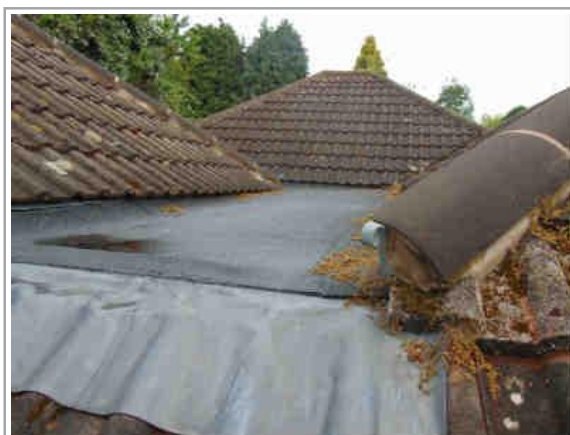
Horizontal Valley - Flat Roof

There is a large horizontal valley area covered with felt. The life span of a flat roof covering is difficult to predict. The surface may appear sound, but a minor defect can cause deterioration to the fabric beneath. Such problems can go undetected for a period of time. Flat roof coverings should be checked regularly and maintained. Detailing to flat roof edges and junctions with walls or roof slopes are vulnerable points and should be kept in good repair. The felt was seen to be in satisfactory condition.

Condition rating: 1

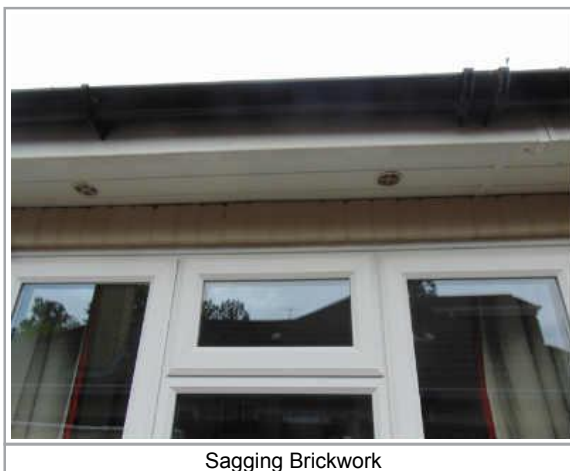
Sagging Brickwork

It is not possible to confirm the presence of lintels over all window and door openings. If windows and doors are replaced in the future there may be a need to provide or upgrade lintels. Sagging was noted in the line of the brick soldier courses over some openings, notably to the rear of the bungalow and over one of the windows to the south side. Immediate action is not required.

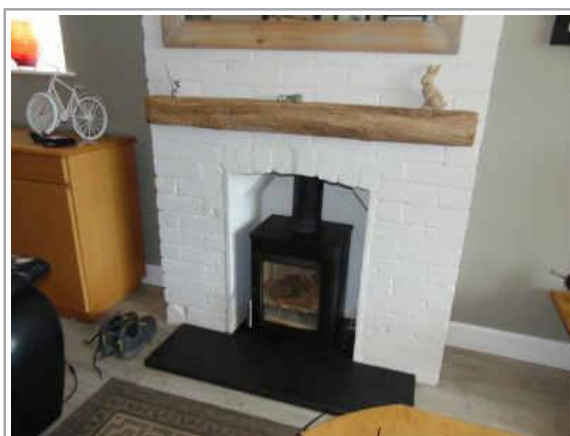
Woodburning Stove

Condition rating: 3

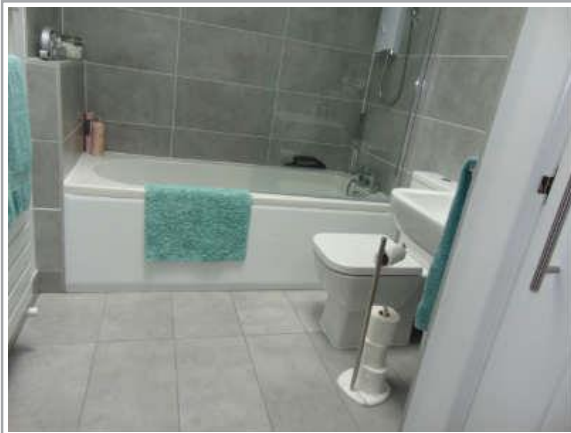
Family Bathroom

Fittings are in satisfactory working order. The extractor to the main bathroom is not functioning and this should be invested and repaired or replaced.

Condition rating: 3

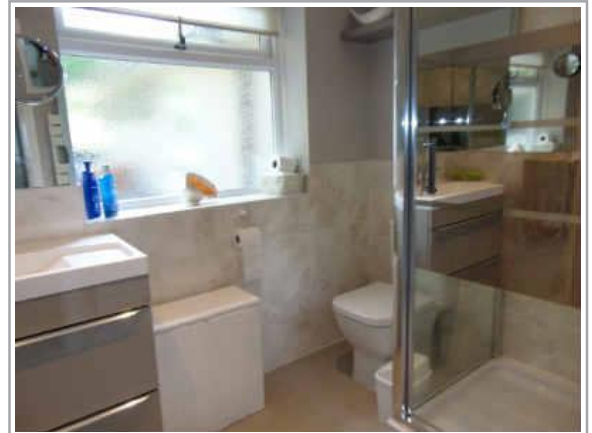
Ensuite

We have not be able to readily identify any Kitemarks on the shower enclosure to the ensuite or shower screen to the family bathroom to confirm the presence of safety glass. We advise the glazing be checked and replaced as necessary.

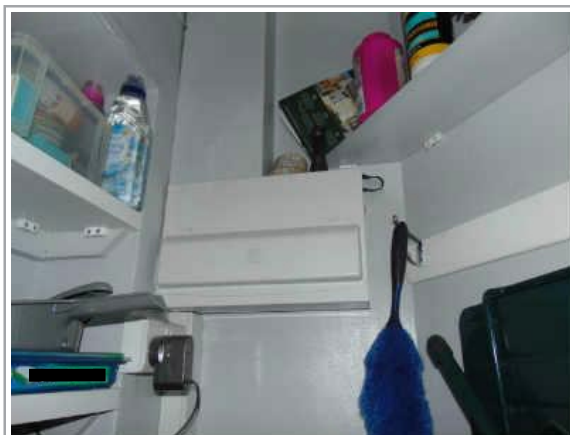
Consumer Unit

Condition rating: 3

If a recent test certificate dated within the last twelve months is not available for the system we recommend inspection by an NICEIC/ECA registered contractor prior to exchange of Contracts.

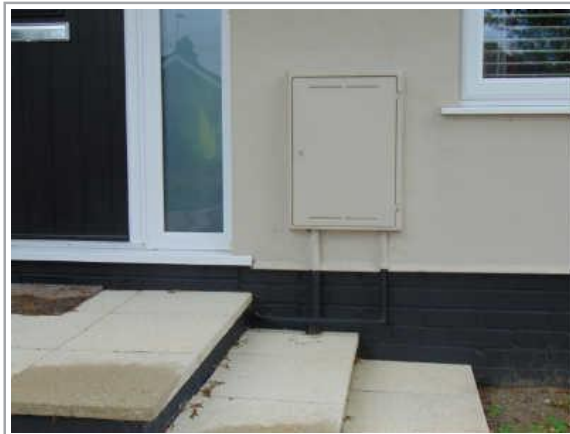
Gas Meter

Condition rating: 3

If a recent test certificate, dated within the last twelve months, is not available for the gas supply and appliances then we recommend they are tested by a 'Gas Safe' registered engineer.

There is a battery operated carbon monoxide detector. It is recommended that mains controlled carbon monoxide detectors are provided and serviced in accordance with manufacturer's instructions.

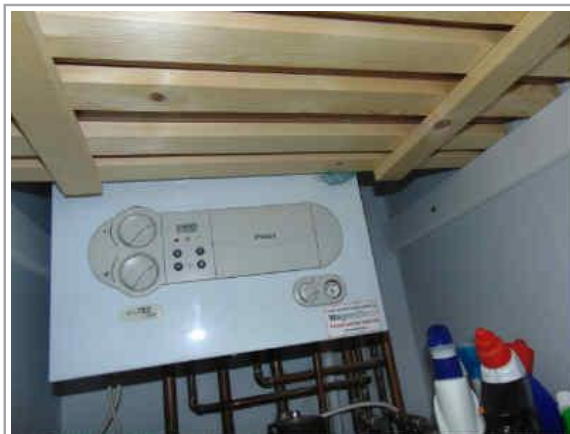
Boiler

Central heating is provided by a Vaillant gas fired boiler located to the bathroom. The boiler serves metal radiators through copper pipes. The visible circulating pipework and radiators were seen to be in satisfactory condition.

The boiler is modern. Legal Advisers should confirm consent for the installation and servicing within the last twelve months. If confirmation is not obtained, inspection by a 'Gas Safe' registered engineer is required.

Condition rating: 3

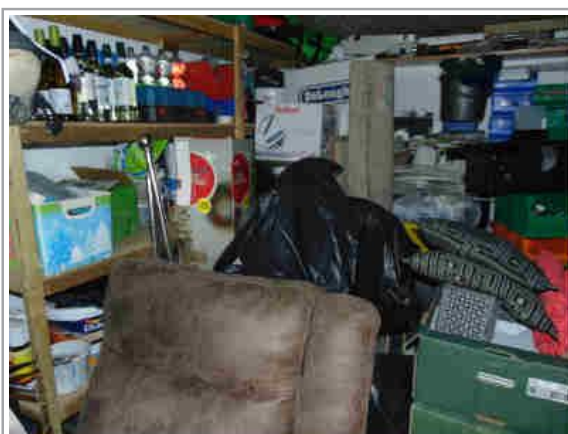
Stored Items - Garage

The garage was completely full of stored items which restricted inspection.

Materials containing asbestos are present in many buildings of this age, often enclosed and unexposed. Asbestos may be present in corrugated roofing material to the garage. The exact nature of the material can only be determined by laboratory testing. There are potential health risks stemming from the inhalation of asbestos fibres and from working with this material. Further advice is available from the local authority or the Health & Safety Executive. Specialist advice should be sought before carrying out any work to these components. The cost of removal may be high.

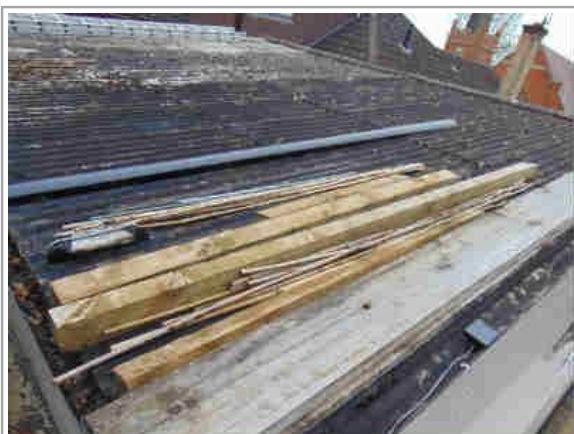
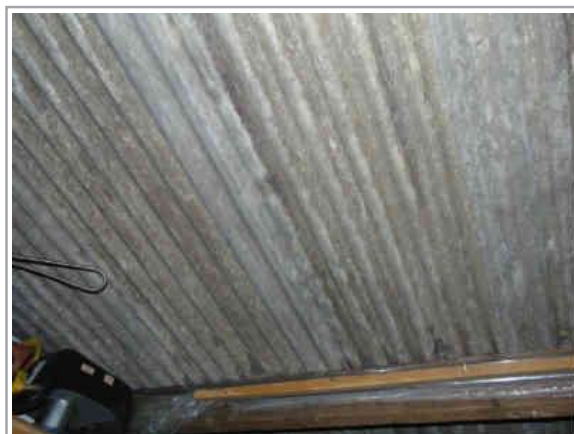
Garage Roof

The garage is constructed of brick walls under a roof formed of timber joists overlaid with corrugated cement asbestos sheeting. There is a small pitched roof section at the front covered with concrete tiles. There are plastic rainwater goods and timber doors to the front. There are uPVC fascias and soffits. The garage was full of stored items which prevented any meaningful internal inspection. The following should be noted:-

1. The corrugated roof covering is at the end of its design life. It is porous and requires replacement. Appropriate precautions should be exercised in removal and disposal of this material, bearing in mind the likely asbestos content.
2. In relation to the pitched roof, the underlay to the underside has perished and requires renewal.
3. Bearing in mind external walls are below ground level, there is every likelihood that this structure will suffer from dampness unless a vertical damp proof membrane has been provided.

Condition rating: 3

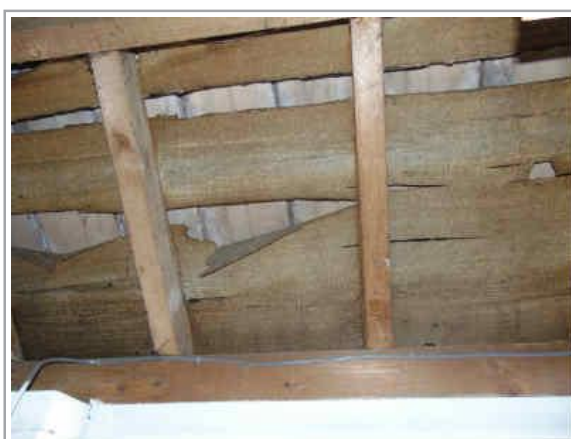
Perished Underlay

G1: Garage - deteriorating roof covering/high ground level/damp risk/perished underlay.

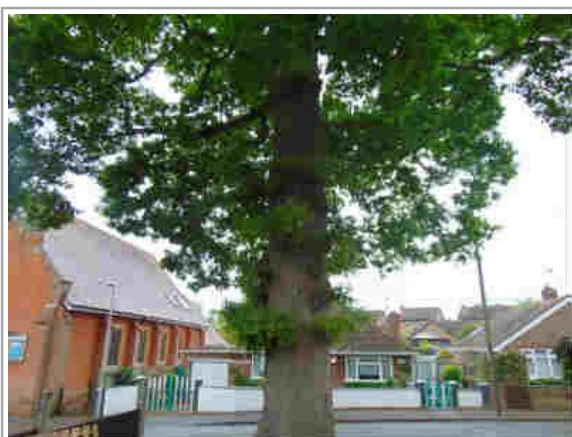
There are various trees within a zone of influence of the bungalow and we note your concerns with regard to the possibility of structural movement. Tree roots can be damaging to building structures and services particularly on shrinkable subsoils. There are no indications to suggest that these trees have caused any damage. It is reasonable to assume that in relation to the extension, the foundation design of the property has taken account of the nature of the trees and the subsoil in the vicinity.

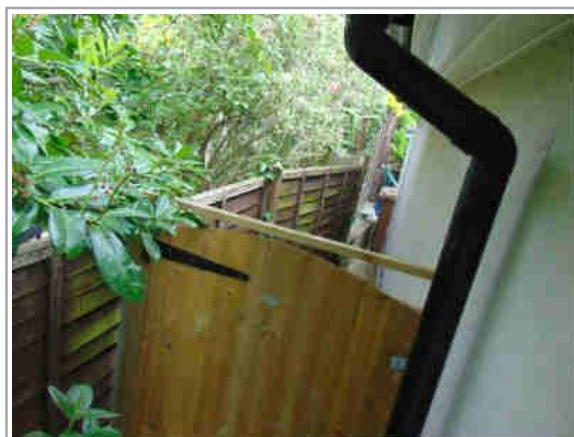
Kink in Boundary Line

Boundaries are marked principally by timber fencing panels. We noted that the boundary line in particular on the north side is not straight with a kink noted. We have not inspected the Title Plan and you should confirm with your Legal Advisers that the fencing on site correctly identifies the

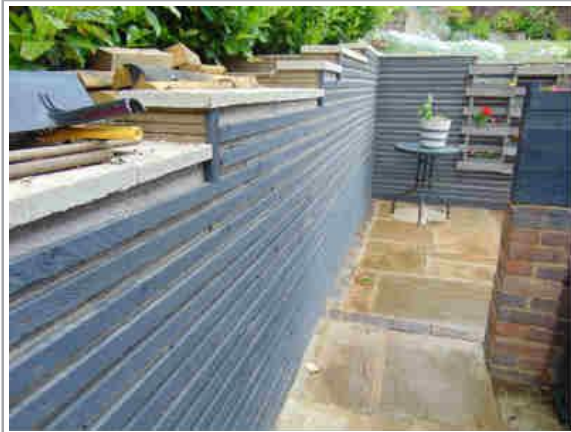
Retaining Walls

The blockwork retaining walls are obscured by timber finishes but we cannot see that weep holes have been provided. We are therefore not in a position to confirm the long term performance of these retaining walls. Retaining walls can fail due to a pressure of water where there are inadequate weep holes.
