LEVEL 2

Your survey and valuation report

[Redacted] 2022

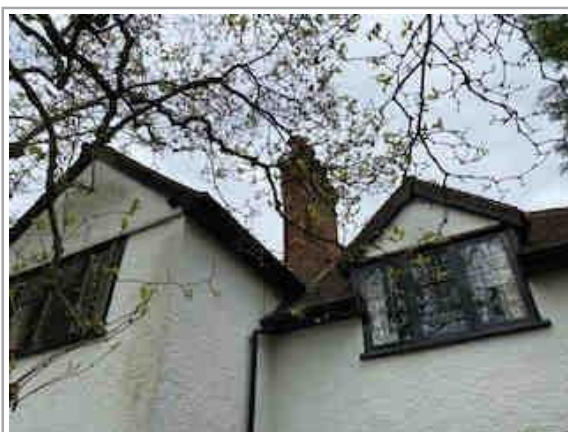
Principal Chimney

The weatherproofing detail to the larger chimney is in the form of a cement fillet. We advise replacement with lead flashings when the roof covering is renewed.

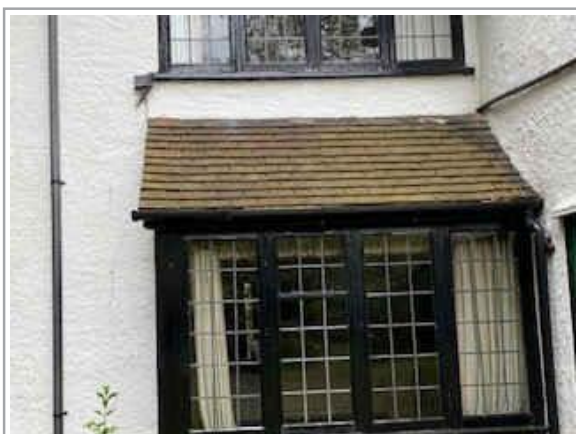
Bay Roof

There is a separate clay tiled roof covering over the rear bay with a cement fillet detail at the abutment with the adjacent wall surfaces and this should be retiled at the same time.

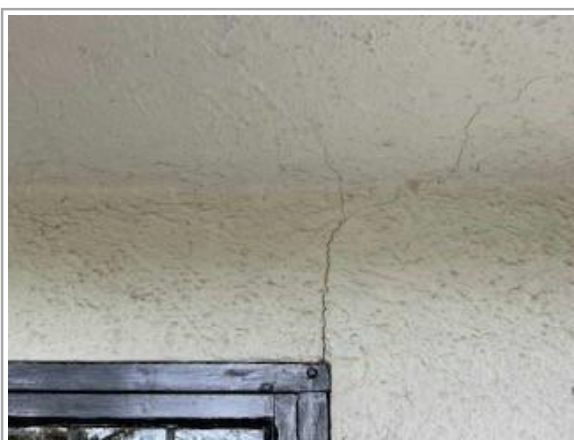
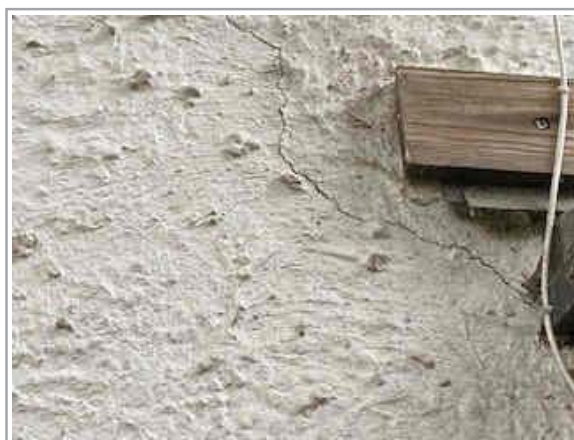
Cracking - Render

There is evidence of movement to the building. Cracking was seen over the window opening to the kitchen and over the door opening to the side of the kitchen. The cracks are relatively small but we cannot exclude the possibility that there is a defect in the drainage system which could cause further movement. We therefore advise a test of the drainage system. Attention is drawn to section F6.

Facing elevations are principally in render. Some localised hollow areas were noted and there is a small area of failure on the east facing elevation. In addition, the paintwork is flaking. The rendering should be repaired and redecorated.

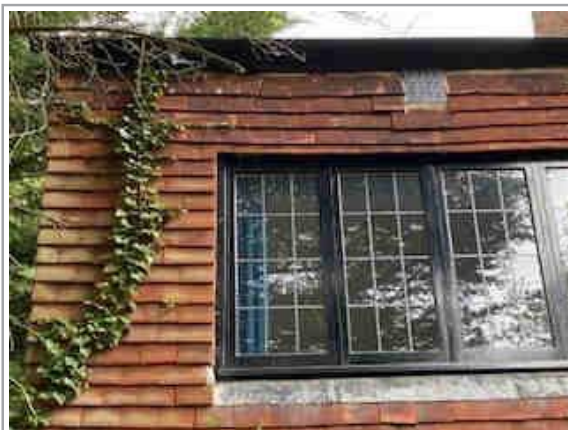
Sagging - Tile Hanging

The first floor accommodation oversails the ground floor to the kitchen and there is slight deflection in the line of a timber fascia at the edge of this detail. It does appear that there has been slight sagging of the accommodation at first floor level and there is associated cracking to plaster internally. The movement similarly appears to be longstanding and non-progressive.

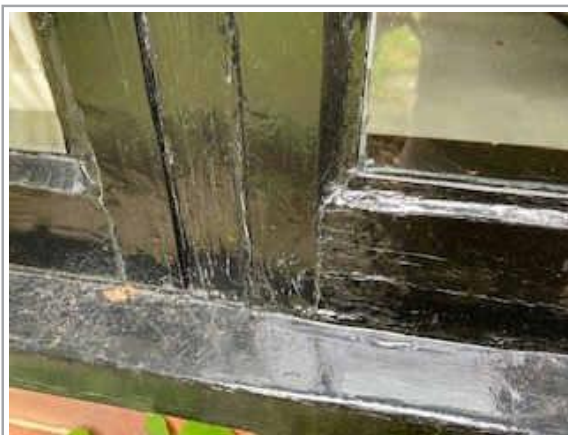
Timber Decay

Despite their age and some warping they are in fair condition to the front of the property. To the rear, however, they are in poor condition with decay evident and evidence of previous patch repairing. The windows have reached the end of their design life and wholesale replacement is required.

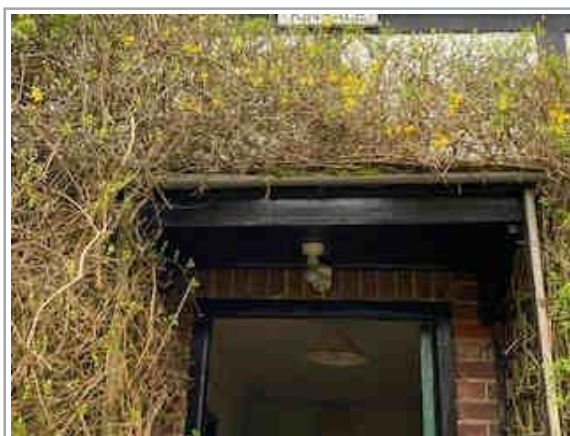
Porch

The timber supporting structure has tilted slightly. The covering is thought to be in felt but was obscured by considerable climber growth which should be removed. The covering appears to be in poor condition and we advise stripping and refelting or replacement.

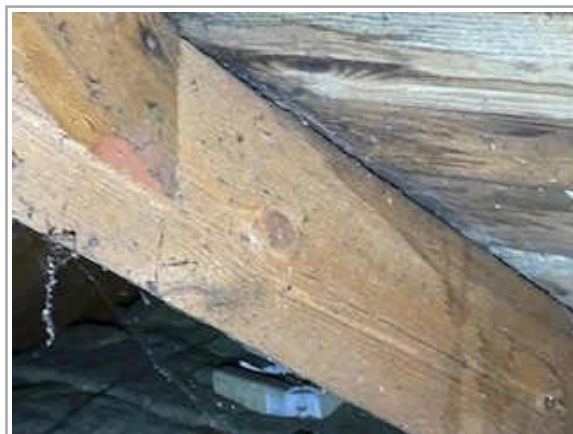
Staining - Roof Frame

Tile dust was noted within the roof space. Additionally, there is widespread staining of the boarding laid over the frame indicative of the deteriorating condition of the tiles. We reaffirm our view that the roof requires retiling.

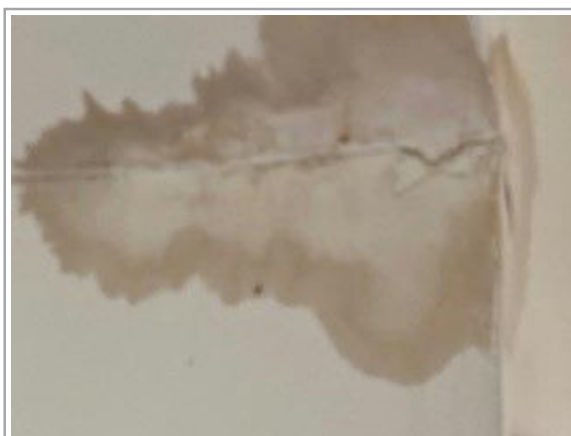
Damp Staining

Water staining was seen to the sloping ceiling to the bedroom over the garage where there has been leakage around the dormer. We have made a separate recommendation that the roof be stripped and retiled and therefore this does not require further investigation.

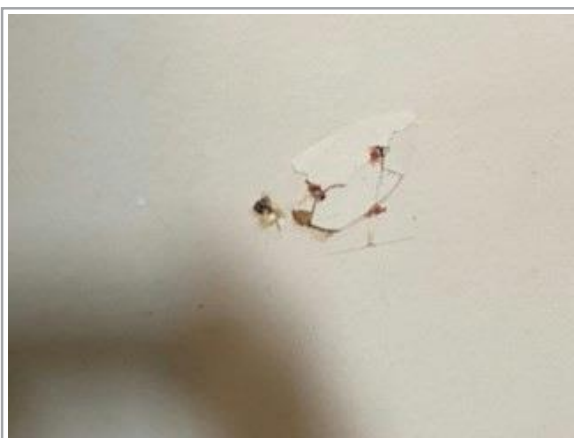
Localised Plaster Damage

Walls are principally of masonry type. There is no evidence of major structural movement to the internal fabric of the building. There are localised areas of plaster damage.

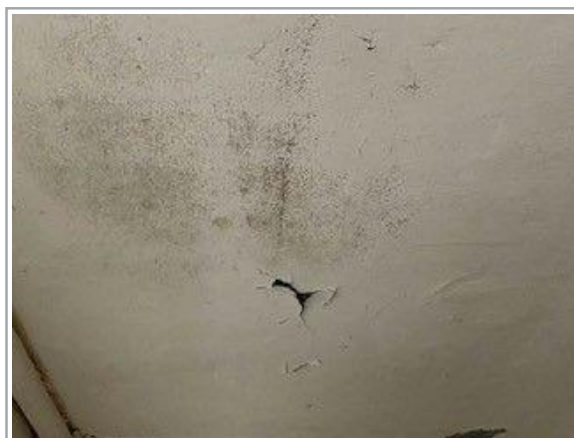
Condensation Staining

Within the larder cupboard we noted mould consistent with the presence of condensation. Condensation may be encountered during the course of normal occupation. If not managed correctly condensation can lead to mould growth which can have adverse health effects. Maintaining a reasonable balance between heating, ventilation and insulation should prevent excessive condensation.

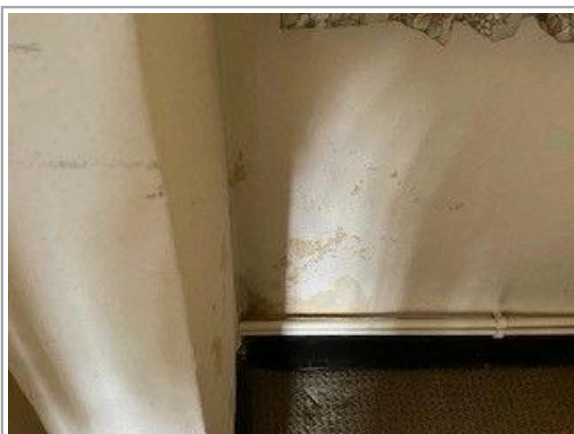
Dampness Staining

Within the morning room in particular, staining was noted to wall surfaces. This is largely dry but some localised high moisture meter readings were obtained and similar readings were also obtained to the dining room between the chimney breast and rear wall. There does not appear to be an extensive rising problem and indeed the dampness to the dining room is probably not associated with rising dampness. It could be due to a leak from the rainwater goods or from moisture transmitting from the support platform from the adjacent water butt.

Nevertheless, we advise you obtain a specialist report in relation to rising dampness and carry out remedial works as necessary. This report should be obtained prior to exchange of Contracts.

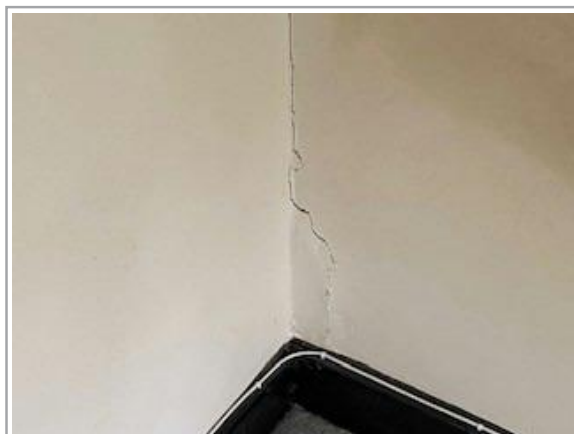
Plaster Cracking

There are widespread plaster cracks, particularly to the kitchen but also at first floor level to bedroom number 3. These do not appear to be associated with an ongoing structural movement issue but we have made a separate recommendation that the drains be the subject of specialist inspection.

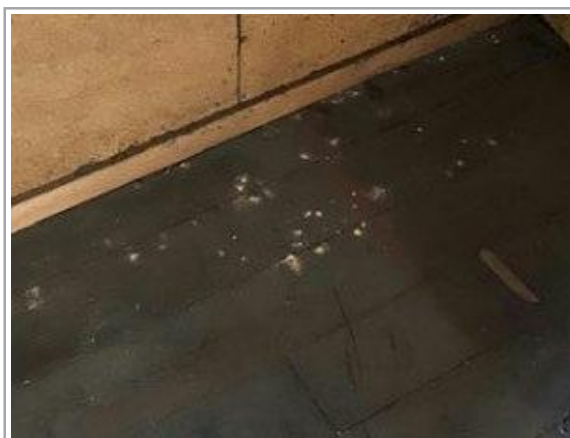
Timber Infestation

The first floors are of suspended timber. They were found to be reasonably level and firm. Evidence of active timber infestation was seen to flooring within the room over the garage and other elements of the building may be affected. A specialist timber report has been recommended under section E1. This should extend to the whole of the property including floors at ground and first floor level.

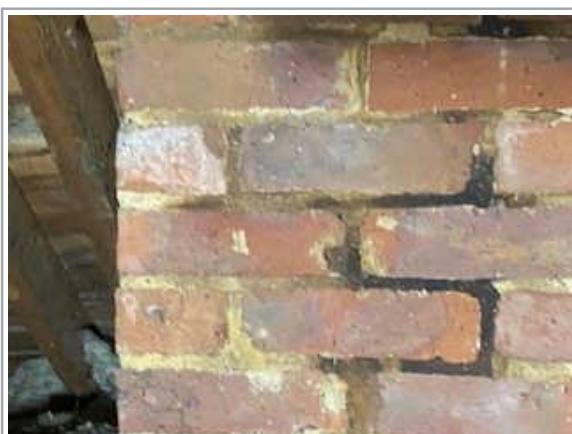
Tar Staining - Roof Space

Within the roof space we noted tar staining to the chimney breast suggesting that the flue linings have deteriorated. If you intend reinstating any open fires the flues will need to be swept and tested and most likely relined. Full inspection by HETAS registered engineer is required.

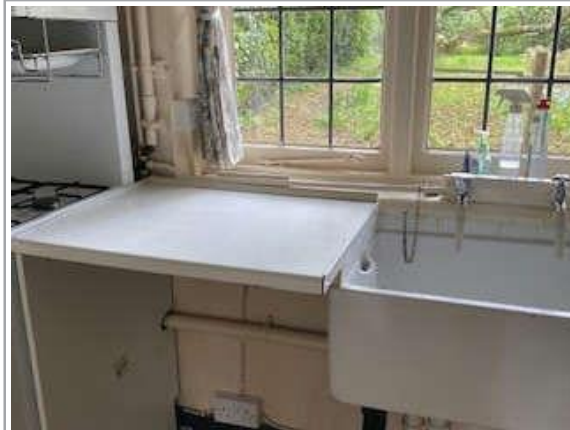
Kitchen fittings are obsolete and in need of replacement.

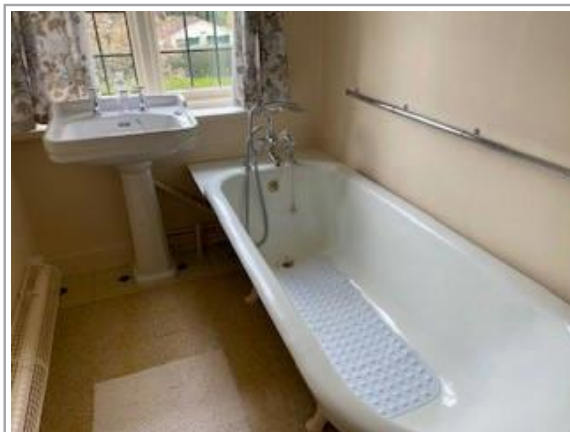
Bathroom

Fittings are obsolete and in need of replacement.

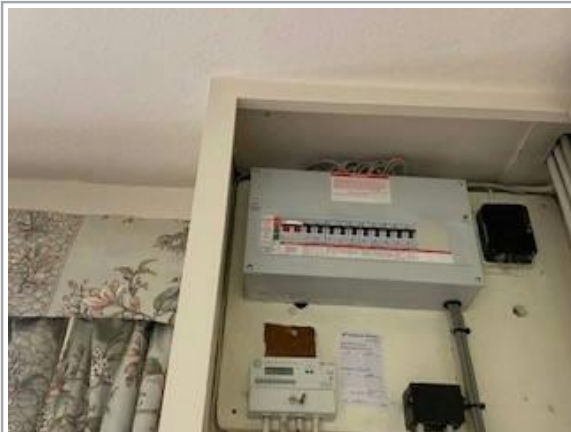
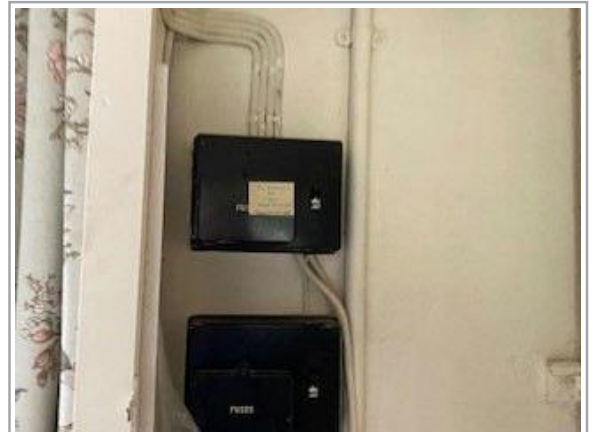
Consumer Unit

The installation has been the subject of partial upgrading with a modern consumer unit. Old elements of the system remain. There is an inadequate number of electrical sockets to some rooms. The full extent of the work required on the system cannot be established without a specialist report.

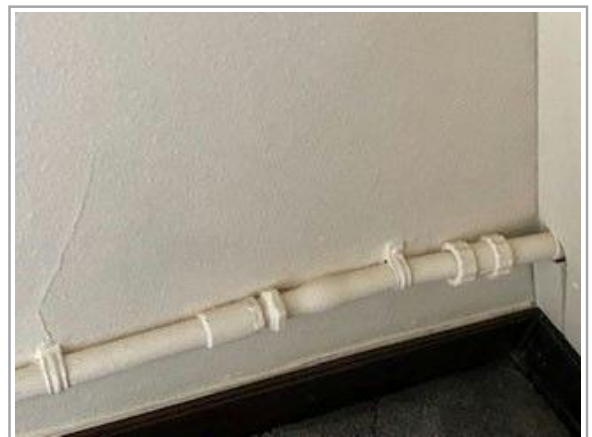
Lead/steel Pipework

Mains water is connected. Plumbing is principally in a mixture of copper and plastic but old steel and lead pipework remains that should be replaced. The incoming water main has been renewed.

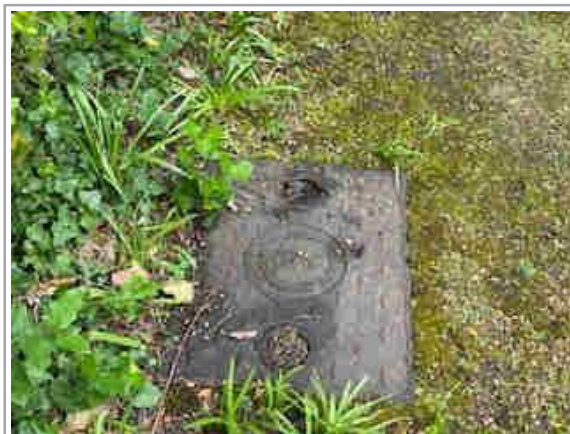
Drainage Chamber

An inspection chamber was located to the front of the house and there are two to the side. The chambers were found to be clear with no evidence of blockage. Attention, however, is drawn to observations regarding cracking noted internally and externally. We advise a test of the drainage system to ensure that there are no concealed leaks.

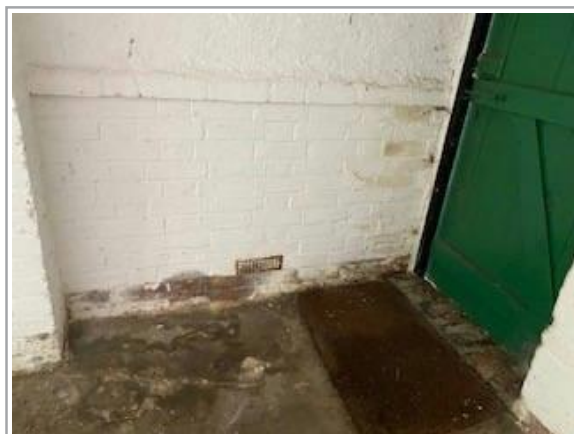
Dampness - Garage

1. Some dampness was noted to the walls which is partly penetrating and this will be difficult to completely eradicate. Dampness will persist below the level of the damp course. The floor is cracked and worn and does not incorporate a damp proof membrane. Some dampness will be encountered. You may wish to consider replacement.
2. Timber doors have dropped to the front of the structure. This is partly associated with the general sagging of the timber frame structure at first floor level.
3. The sheet material to the ceiling is believed to be an asbestos containing material. Visible parts do not appear damaged, but this material can be a health hazard. Specialist advice should be obtained before carrying out any work affecting these components.
4. The timber window to the side is decayed and should be replaced.
