LEVEL 3

Your survey report

Surveyor's RICS number
0068792

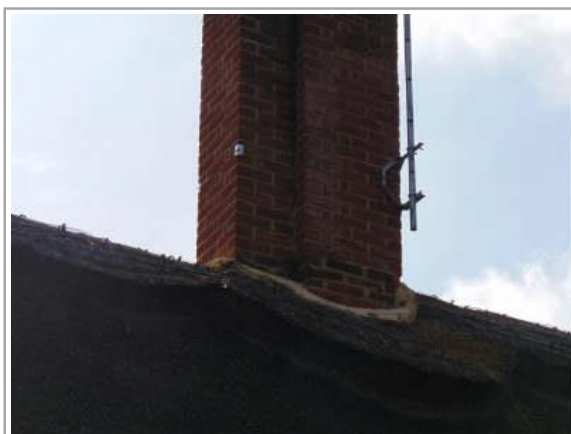
Chimney stack

The condition of the brickwork would suggest the chimney stack has been extended in height. Brickwork and pointing is in satisfactory condition. There are concrete copings on the top of the chimney to reduce the risk of rainwater running down the chimney flue.

The weatherproofing detail between the chimney and adjacent roof thatch is in the form of a cement mortar. Flashings formed with cement mortar or tiles bedded in cement mortar are very prone to cracking and failure so usually require regular maintenance/repair to keep them reasonably watertight. Alternatively, they can be replaced with lead which is more effective and durable. Flashings should be correctly wedged in place so as to avoid slippage and the mortar pointing falling out. Cement as opposed to lead, however, is often used in relation to thatched roofs.

There is a TV aerial attached to the chimney. Great care needs to be taken with items fixed to chimney stacks, for example TV aerials and satellite dishes, which impose added stresses and strains upon the structure for which it was not designed especially during very windy weather conditions. In extreme cases, structural failure can occur. Even where apparently sound, such fixings should be monitored and checked on a regular basis.

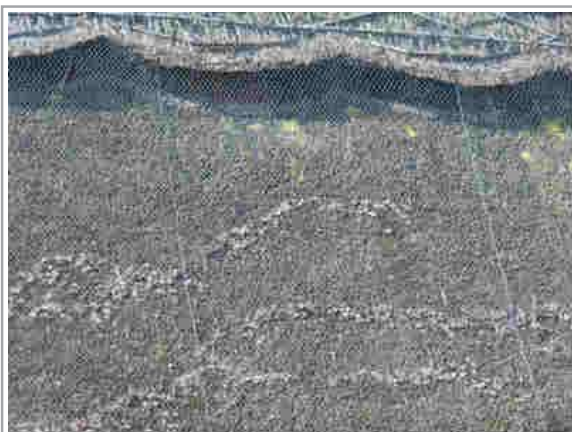
The thatch was seen to be in satisfactory condition and has been overlaid with protective metal netting. There is a slight build-up of moss on the surface of the roof. This will not impair the overall performance of the roof in the short term but it is important you engage the services of a thatcher on a bi-annual basis to check the covering, carry out any minor repairs and remove any excess moss.

Light moss

To maintain the roof in good condition trees close to the roof should be regularly cut back (consent will be required for this bearing in mind the property is in a Conservation Area) to ensure the roof is exposed to the maximum amount of sunlight to allow drying out and to reduce the potential for moss developing.

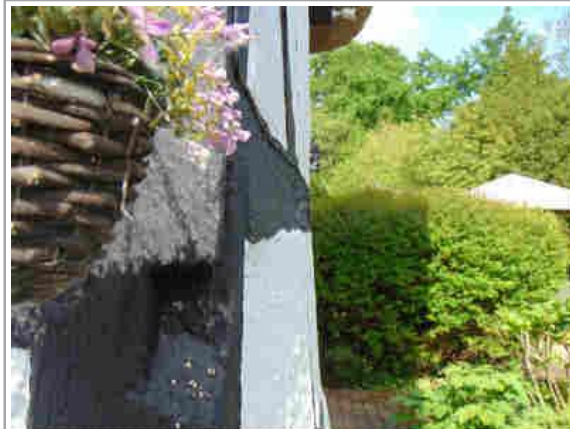
The timber frame has distorted and has been affected by woodboring beetle, but in context of its age is in satisfactory condition; no repairs are required at the current time. There is some metal straps to the frame which have been provided retrospectively.

Distortion - front wall

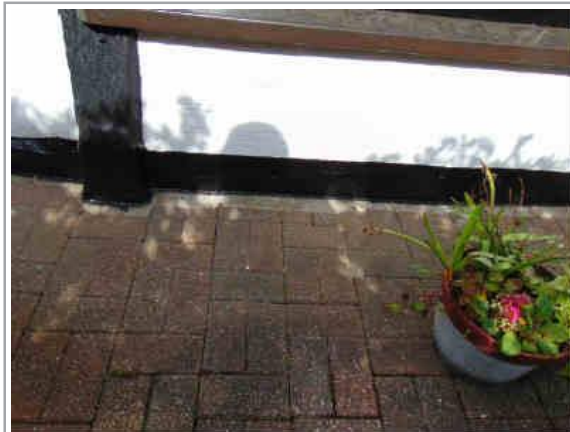
High ground level

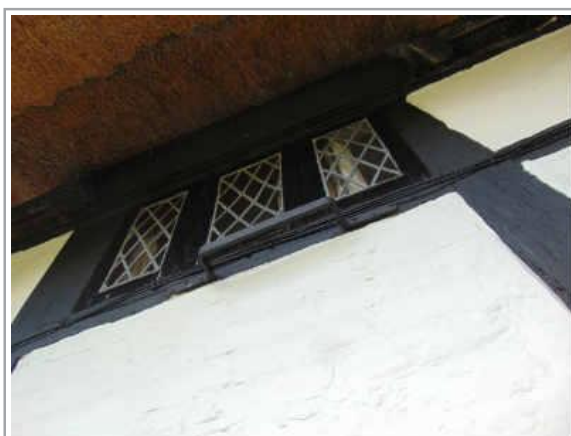
Distorted lead work

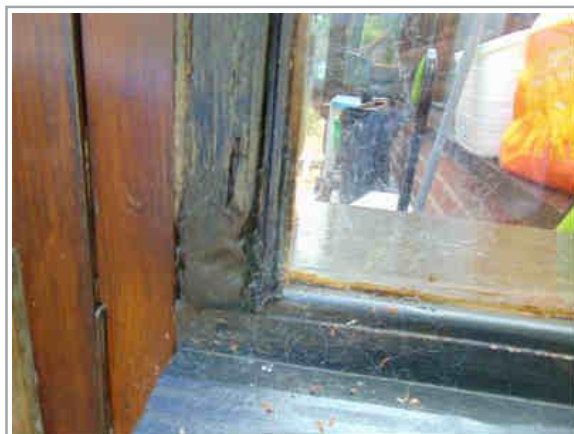
Some minor wet rot decay was noted which is reported upon in relation to the conservatory/utility room.

Decayed window

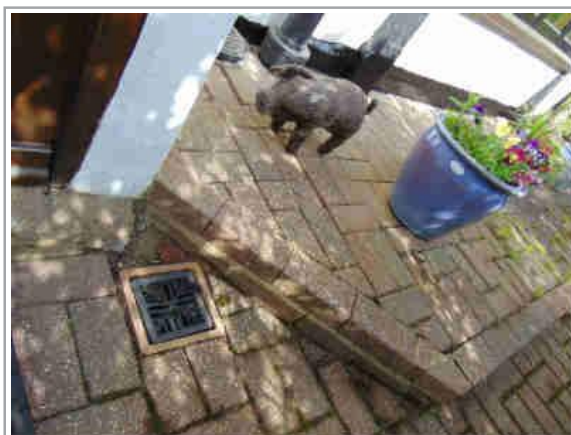
High ground level - porch

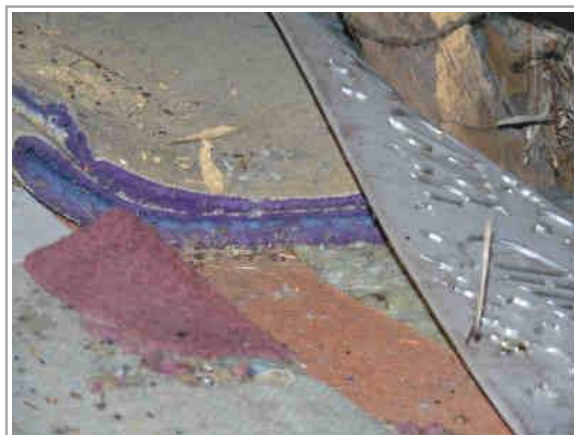
We have outlined earlier the building has been affected by woodboring beetle and this may be active. In relation to the garage stored items restricted inspection but we noted a limited number of holes on one of the accessible timbers which might be indicative of some localised infestation. [REDACTED]

Frass

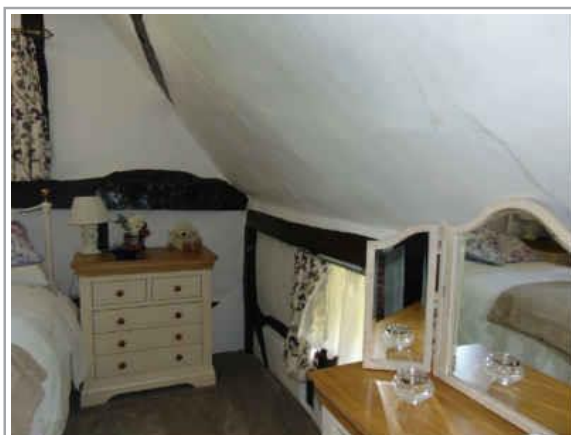
Crack - uneven ceiling

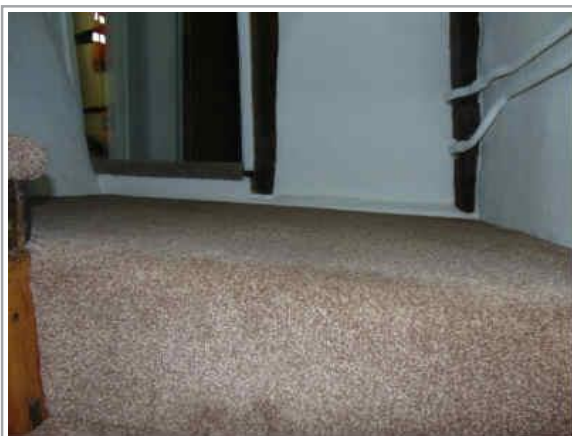
Sloping floor - landing

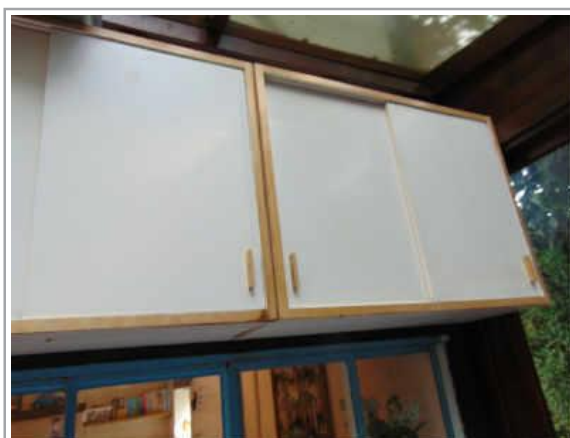
The conservatory is used as a utility room and the fittings are of mixed age and generally the wall units are old and due for replacement. Work surfaces are in melamine.

Older units - utility room

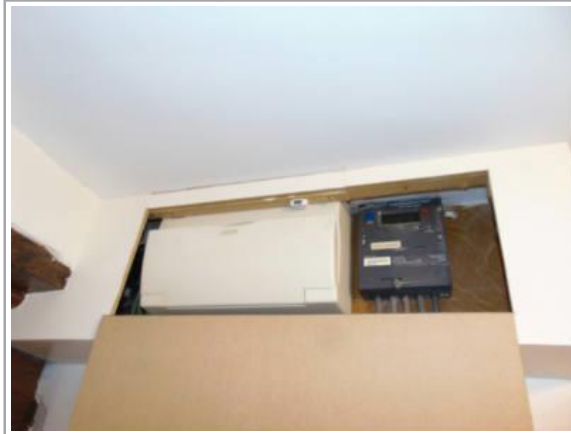
Principal consumer unit

Fires to thatched roofs are still caused by electrical faults. Despite the fact the electrical installation is relatively modern we advise you obtain a specialist electrical report in relation to the whole of the installation from an NICEIC registered contractor prior to exchange of Contracts.

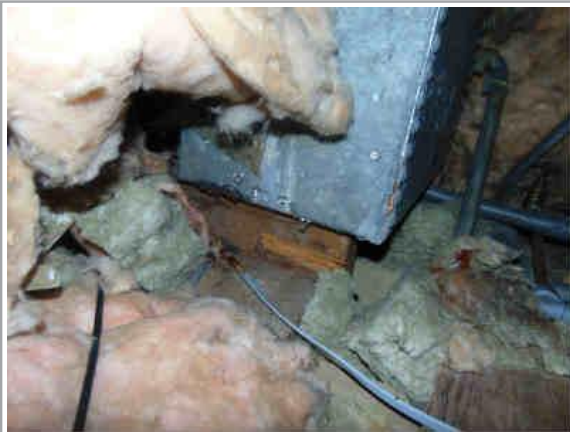
Corrosion - feed/expansion tank

Repairs	Cost guidance (optional)
F4: Heating - replace feed and expansion tank.

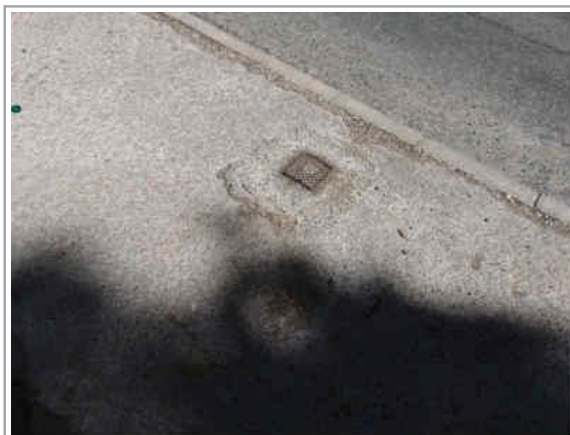
Possible water company stopcock - road

A plumber should be engaged to inspect the plumbing installation and in particular advise upon the condition of the incoming water main between the company and household stopcocks (F3).

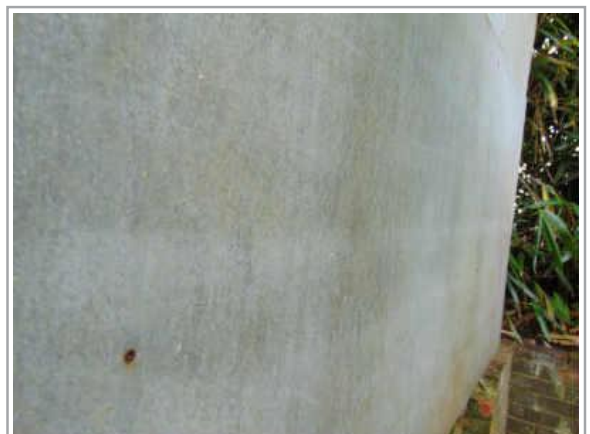
Fire protection - tank - possible asbestos

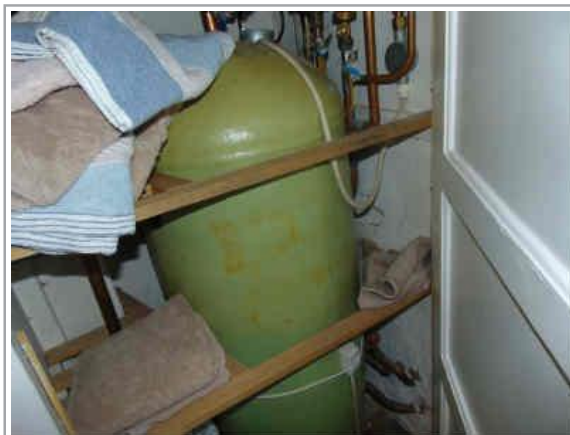
Hot water cylinder

The hot water cylinder is relatively small for a three bedroom property and we suspect it pre-dates the most recent extension to the house. You may wish to consider upgrading. An opportune time to do this would be if replacement of the incoming water pipework is required.

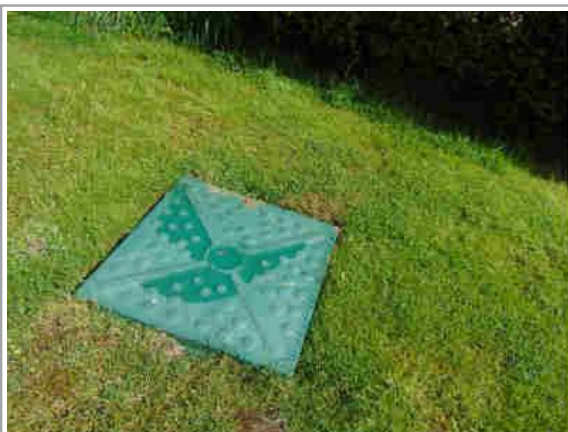
Treatment plant

The Vendor advises the sewage treatment plant was damaged by a lorry in 2018/19 and the plant was replaced under an insurance claim. Legal Advisers should confirm the installation has been the subject of inspection by a specialist and servicing within the last twelve months. If confirmation is not obtained inspection by a specialist contractor is advised.

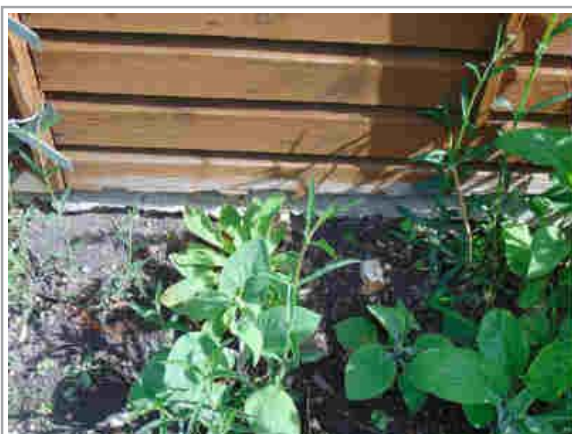
Decayed cladding

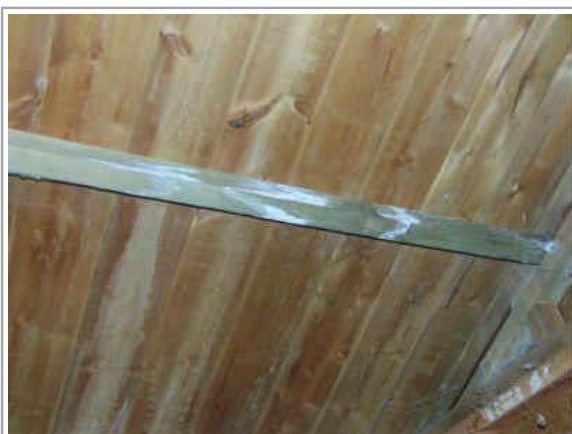
Old staining - roof timbers

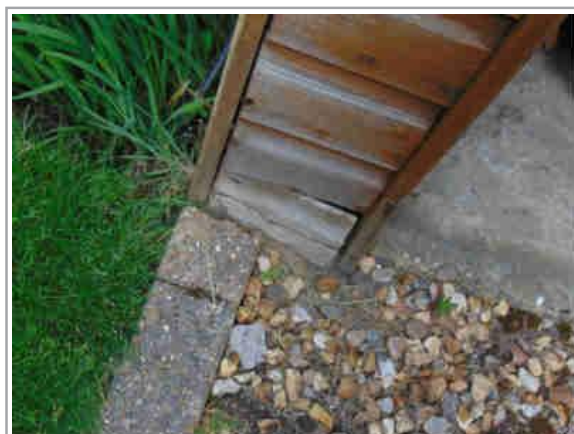
Defective cladding

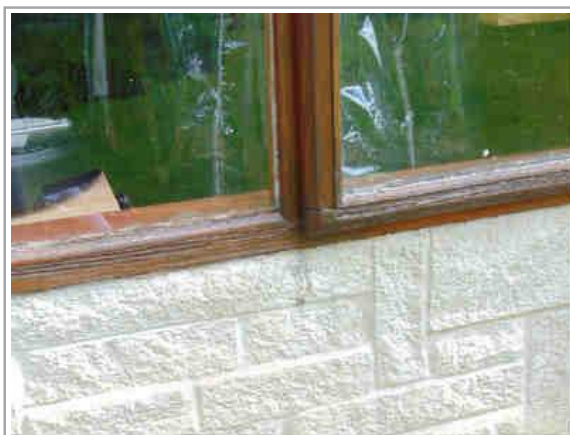
5. There are single glazed windows and decay was noted to at least one of the windows and door and repairs should be undertaken as necessary.

Decayed window
