LEVEL 3

Your survey report

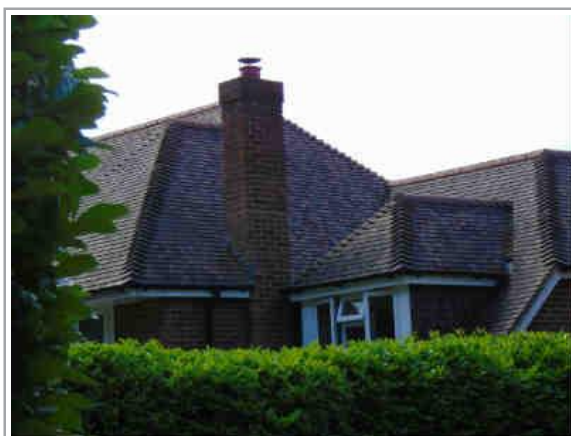
Chimney

The chimney was seen to be acceptably plumb and true. Brickwork, pointing and lead flashings are in satisfactory condition. The chimney incorporates a damp proof membrane. There is a flue protector to the top.

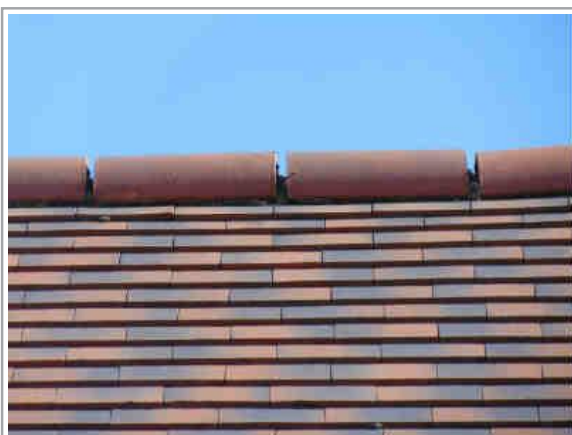
The tiles are modern and the property was re-roofed when it was extended in 2010. The tiles exhibit no signs of significant deterioration. The verges, where the tiles overhang the edge of the roof, have been suitably formed and are adequately pointed up. The cement bedding to the ridge and hip tiles is in satisfactory condition. In relation to a small number of ridge tiles the cement pointing has in part been omitted and the need for future maintenance will arise but works are not urgent.

Missing pointing - ridge

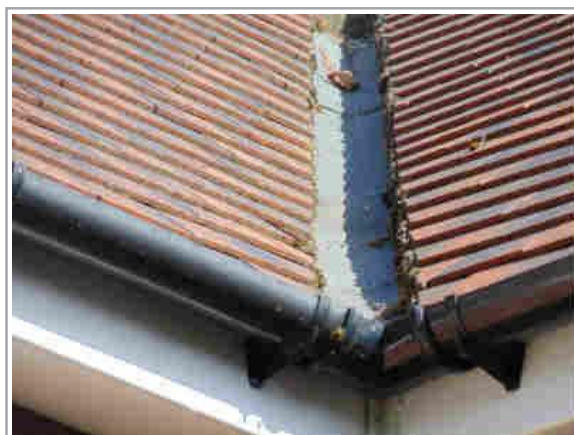
Sloping valley

To the rear of the property there are two sloping valleys which are lined in lead or similar. The linings were seen to be in satisfactory condition.

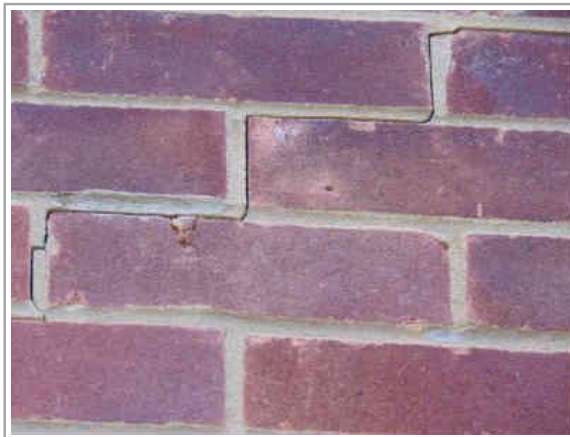
We have comment separately the walls exhibit no signs of significant movement that is foundation related. There is a faint crack to the rear elevation over the door opening to the dining room. We would attribute this to slight movement, most likely caused by the absence of a lintel over the opening to the dining room. A lintel now appears to have been installed retrospectively and there is no prospect the cracking will worsen. Whilst the cracking is extremely fine it would be advisable to have this pointed-in.

Cracking - rear elevation

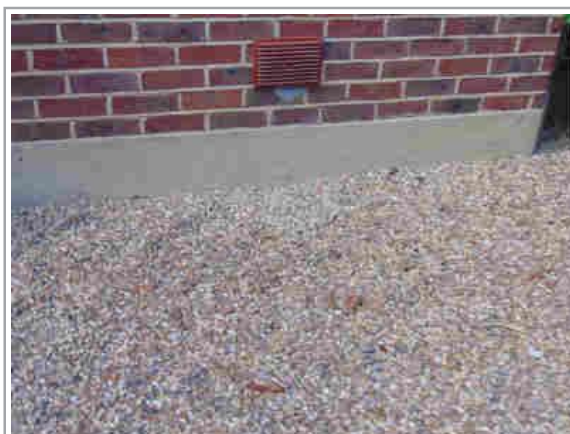
The recommended minimum height for a horizontal damp proof course above external ground level is 150mm. The damp proof is clear of the ground.

No excessive moisture readings were obtained. This suggests that the damp course is performing satisfactorily.

Rendered plinth - damp course

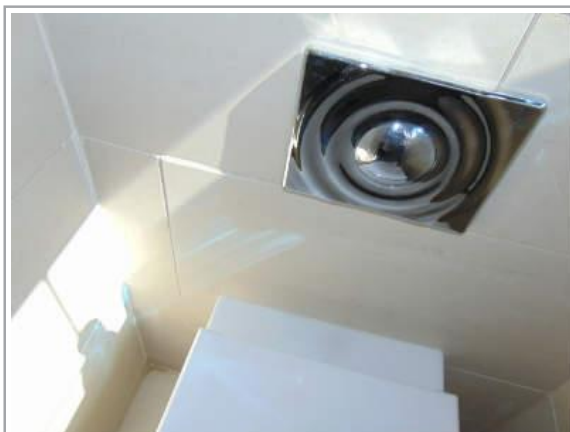
Wall tiling provided to the bath and shower rooms is of variable quality but, nevertheless, effective.

Rudimentary tiling

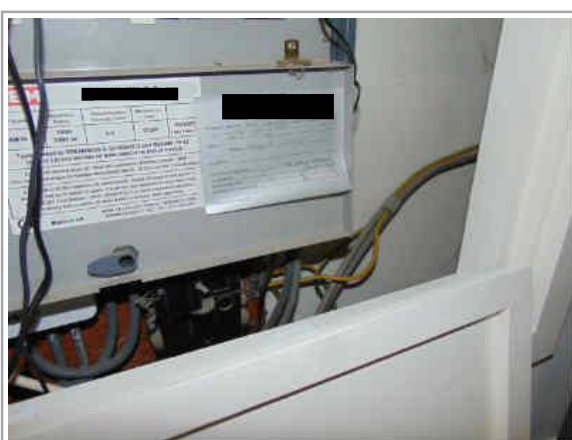
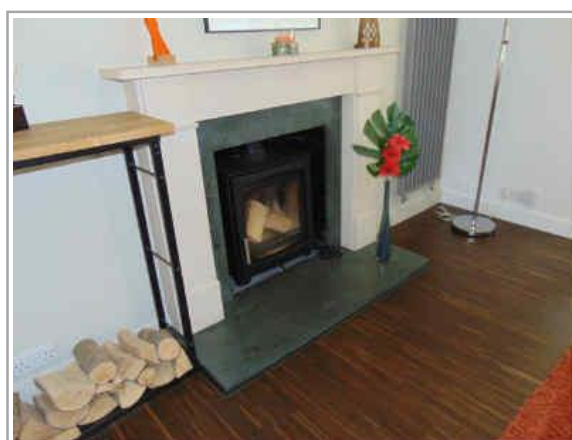
Woodburning stove

The Vendor has provided documentation confirming HETAS certification. Legal Advisers should confirm the existence of any guarantee and servicing in accordance with manufacturers guidance. If servicing is not confirmed inspection by a HETAS registered engineer prior to use is advised.

Condition rating: 3

Information plate - woodburning stove

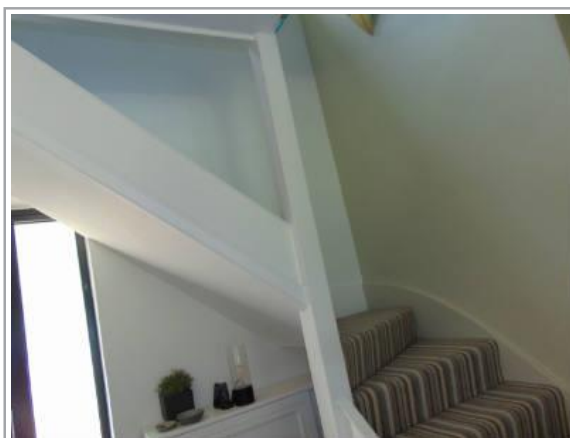
Gapping - staircase

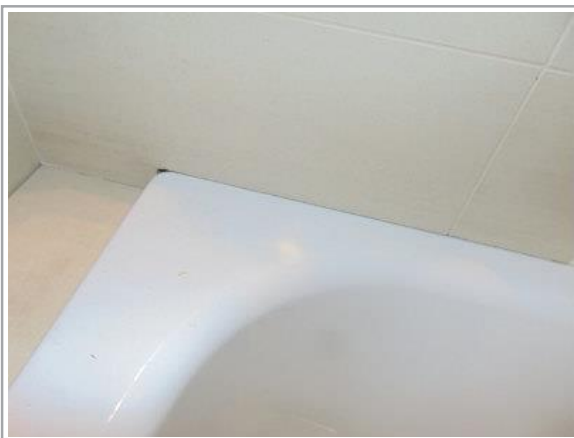
Incomplete seal - bath

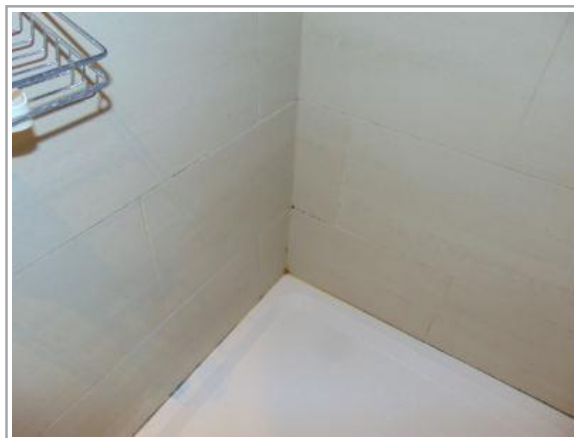
Mould on grout - shower room

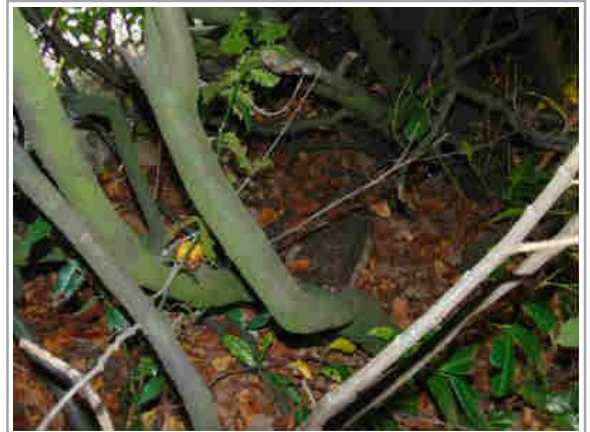
Not all drainage chamber covers could be lifted to inspect the drains.

Inaccessible drainage chamber

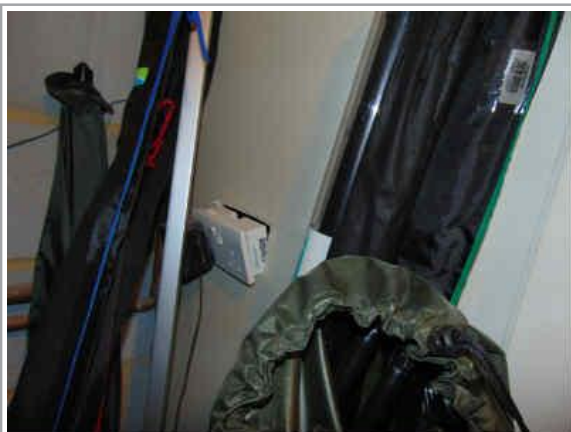
Condition rating: 3

Loose electrical socket

If a recent satisfactory test certificate, dated within the last twelve months, is not available for the installation then we recommend it is tested by an NICEIC/ECA registered contractor prior to exchange of Contracts.

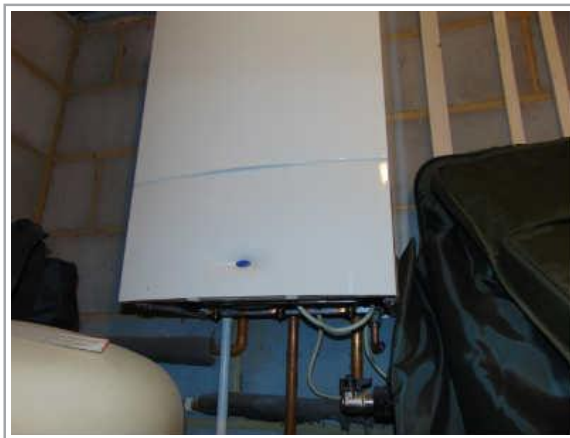
Boiler

The Vendors advise the boiler is approximately five years old. Legal Advisers should confirm it has been serviced within the last twelve months. They should also confirm consent for installation of the boiler. It is understood there is a guarantee expiring in July 2025 and Legal Advisers should confirm.

Condition rating: 3

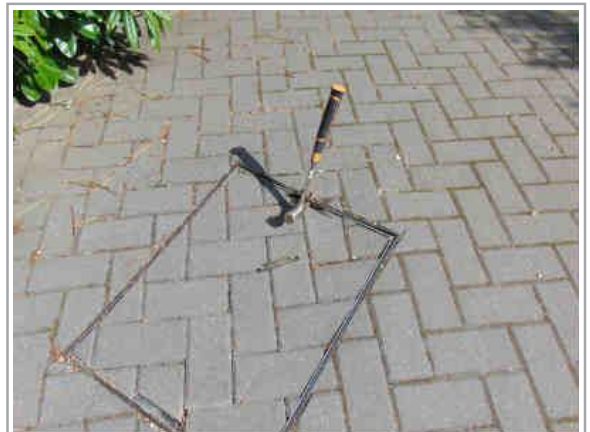
Drainage chamber - driveway

The chambers that could be inspected were noted to be clear with no evidence of blockage. The Vendor advises during his period of ownership he has experienced no problems with blockages to the drainage system.

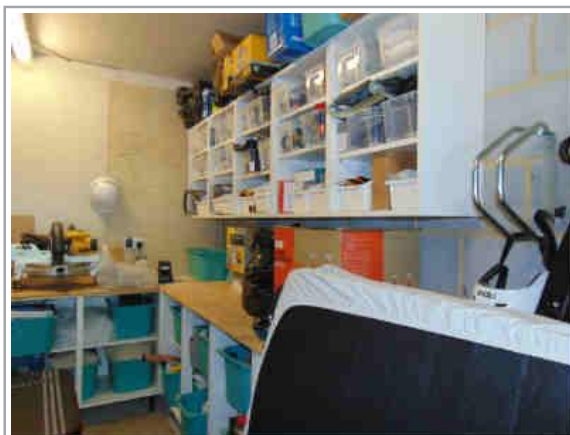
The garage was full of stored items which restricted inspection.

Stored items - garage

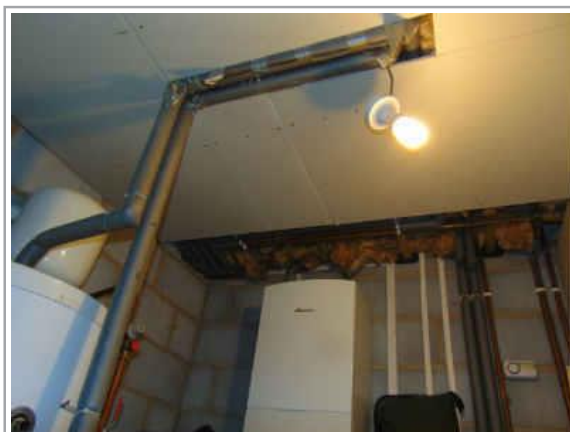
Condition rating: 3

Incomplete ceiling

Repairs	Cost guidance (optional)
G1: Garage - repair ceiling.
