**LEVEL 2**

# Your survey report

0068792

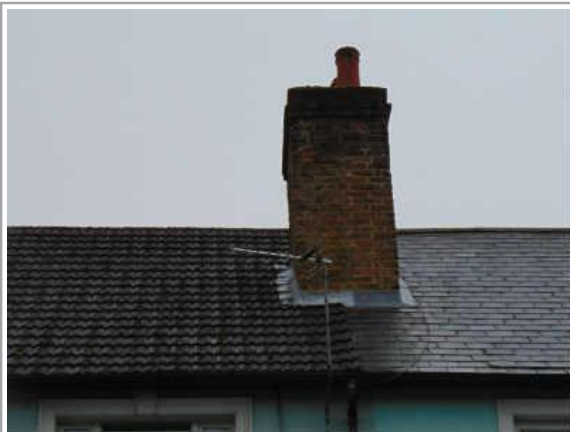
Front chimney

**Condition rating: 1**

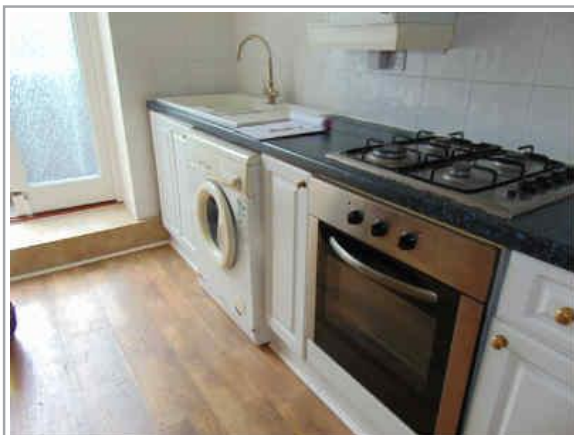
Kitchen

Condition rating: 2

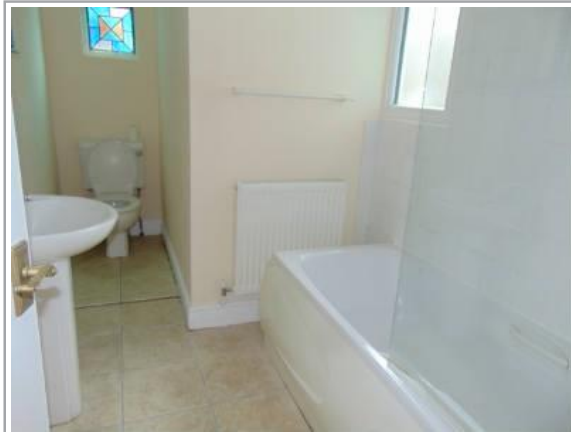
Bathroom

Condition rating: 1

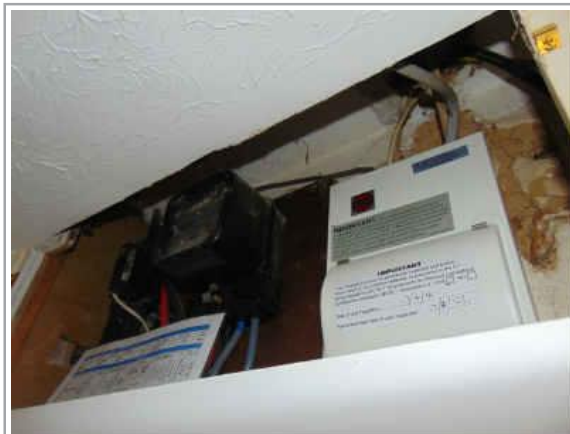
Consumer unit

**Condition rating: 3**

If a recent test certificate dated within the last twelve months is not available for the system we recommend inspection by an NICEIC/ECA registered contractor prior to exchange of Contracts.

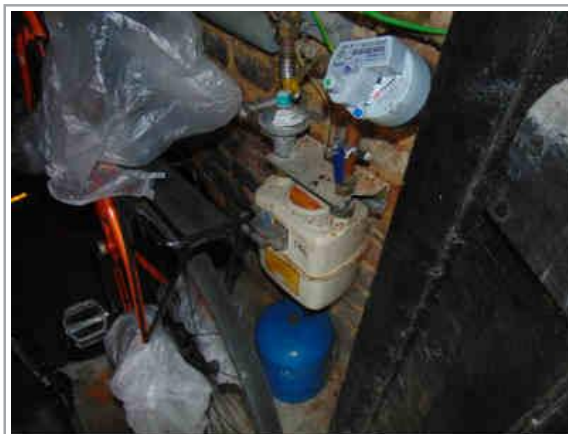
Gas meter

**Condition rating: 3**

There is a battery operated carbon monoxide detectors. It is recommended that mains controlled carbon monoxide detectors are provided and serviced in accordance with manufacturer's instructions.

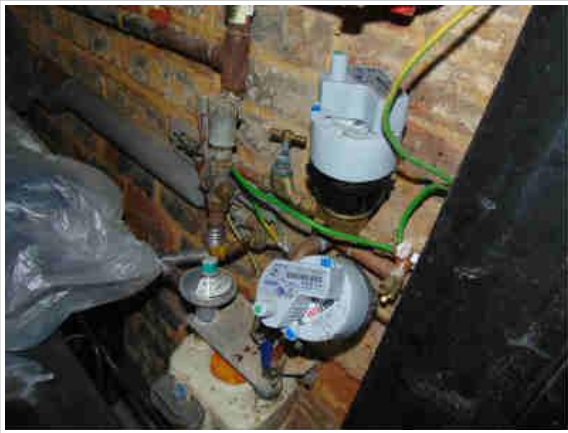
Stopcocks

**Condition rating: 1**

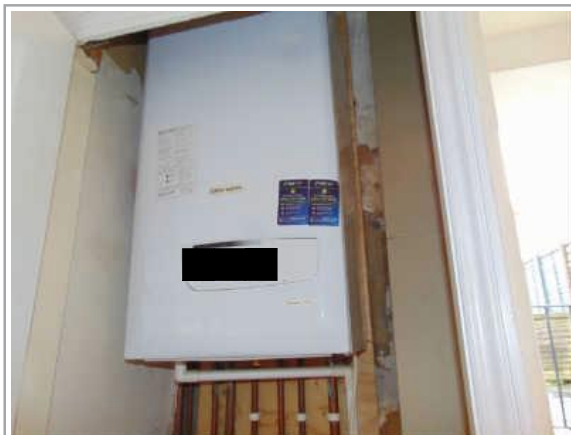
Boiler

The boiler is reasonably modern. Legal Advisers should confirm consent for installation of the boiler and servicing within the last twelve months. If confirmation is not obtained inspection by a 'Gas Safe' registered engineer is required.

**Condition rating: 3**

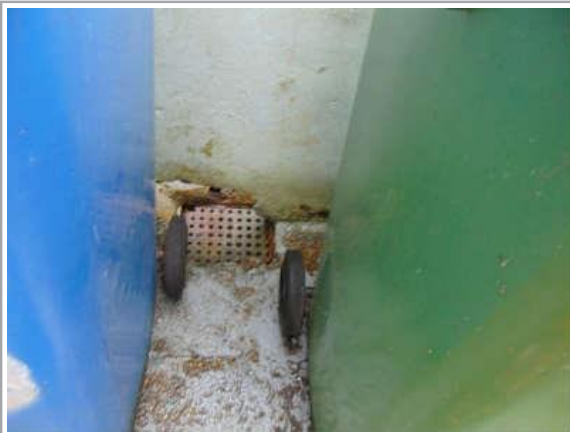
Drainage gulley - front

In accordance with Standard Conditions of Engagement below ground drainage has not been inspected. There are no drainage chambers to facilitate an inspection.

**Condition rating: Not inspected**
